Safety Inspection Report

Annual Inspection

The Butts

Fowlmere Parish Council

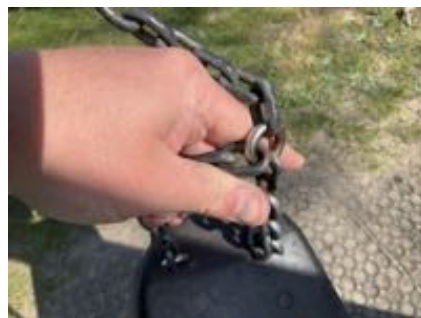
Swing - Junior - 2 Bay 3 Seat

Some chain wear.

The covers should be removed from the fitting at the top of the chain annually and the shackle bolt should be checked for wear. Check the security of the fittings too.

Monitor for further deterioration and replace before 40% wear.

Replace at 70% of original diameter (30% wear).

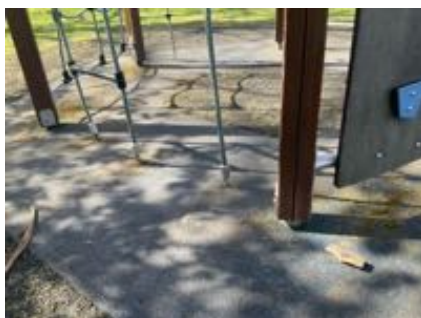
Climber - Frame & Net

Fixtures loose or missing.

Several post shoe bolts are loosening providing excess movement when in use.

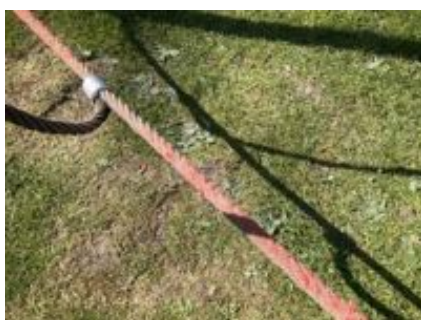
Agility Trail - Fantasy Fun Run

Rope wire exposed. Tape over and replace when damaged.

Cap missing.

Replace.

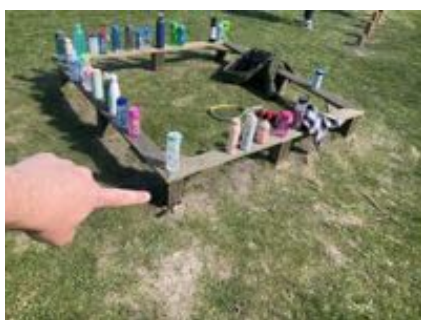
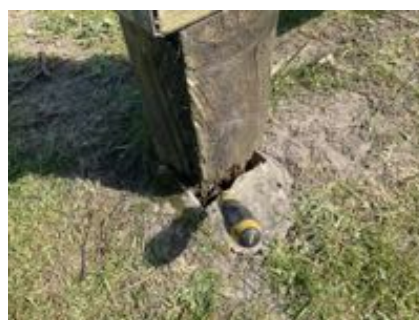
Balance Beam - Square

Timber is decayed.

One post decayed through at ground level. Replace.

Replace affected parts.

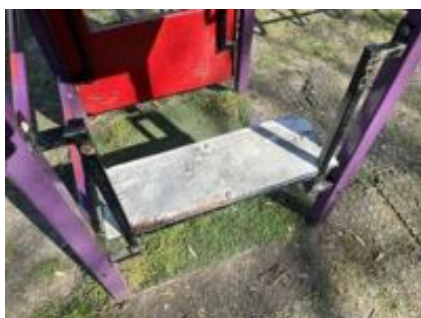
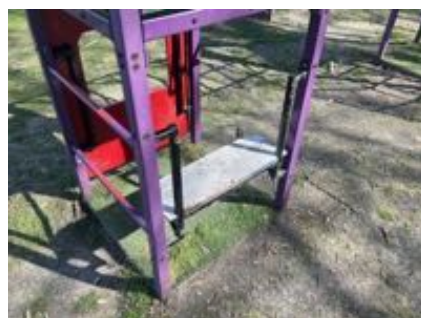
Multiplay - Rainbow

Moderate repairs are needed.

Bottom seat laminate damaged and other is missing. Repair and replace. Replace missing play panel sections.

Read the notes for further action., Replace.

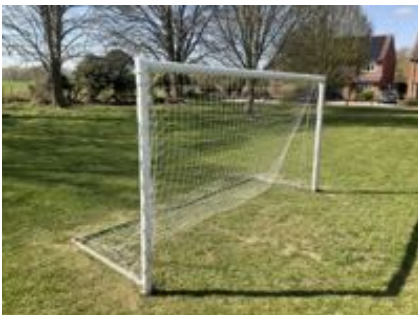
Football Goal - Youth, Small-Sided, Mini-Soccer Or Futsal

Net ground fixing bar loose and projects past the goal post. Securely peg down.

Loose in ground.

Loose in their ground sockets.

Repair.

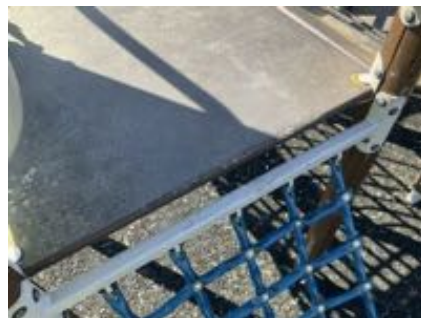
Multiplay - Junior

1. There is wear on the platform.
2. Chain covers prevent a thorough inspection of all chain links.
3. Bolt(s) missing.

There is wear on the platform.

Repair.

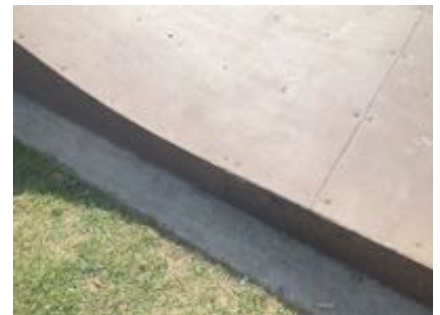
Wheeled Sport - Scooter Combination Triple Half Pipe Ramps

Coping end cap missing. Replace.

Repair.

Repair damaged areas to the riding surface.

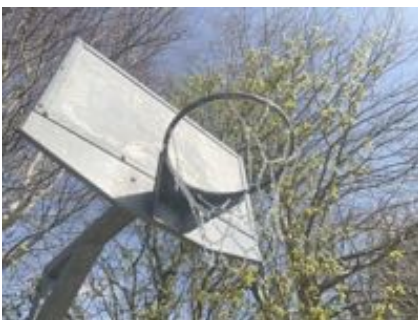
Basketball Area

1. The net is damaged.
2. Encroaching vegetation or trees.

The net is damaged.

Chain net damaged.

A clearly visible sign must be fitted to all sports related equipment with at least the following: a) equipment is not intended for children less than 36 month, b) "Do not climb on the framework or nets", c) "Do not hang on the ring", d) "Do not wear rings or other jewellery as these can get caught and cause injury", e) name and telephone number of site owner, f) number to call in case of accident.

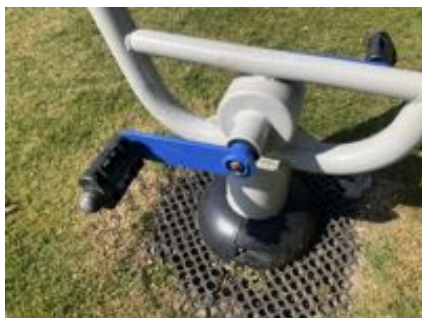
Adult Fitness - Pedal & Hand Cycle

Cap missing.

Replace.

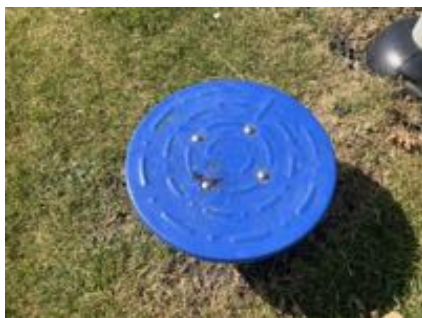
Adult Fitness - Hip Twister

Item is rusting in places.

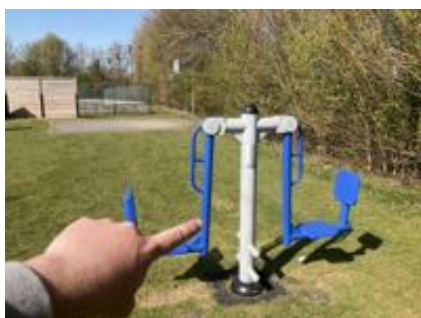
Adult Fitness - Leg Press

Additional comments are noted below.
